## Rehabilitation of Damaged Pier-Pile Joints in Tooz Bridge Using RC Confined By Steel Casing

### Abstract

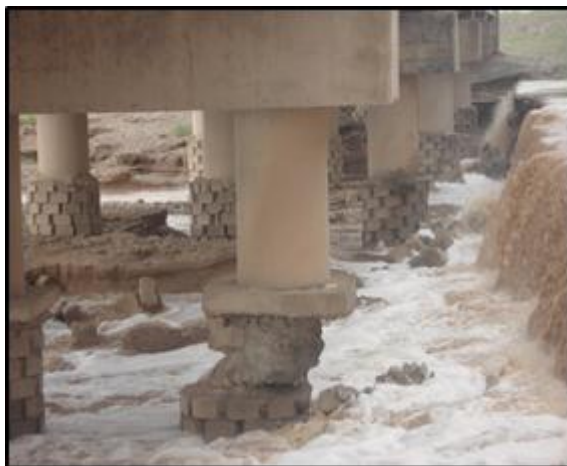
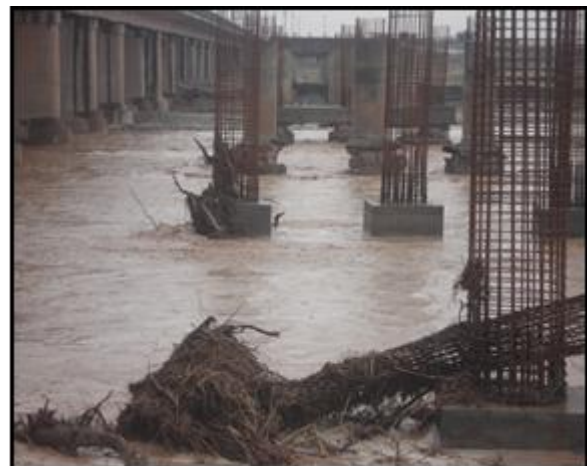
Over the past years, Tooz bridge (Iraqi city situated in North-East Iraq and follow the Salah Al-Din Governorate) has been subjected to severely torrents led to erosion and collapse of soil at pile heads during execution, causing some damages to the heads of piles (joint between the pier and the pile) and its aspects as shown in Fig.(1).

**Figure 1:** Damages at the Heads of Piles (Joint) and at Aspects  
After a site visit by the consultants team to the site of the bridge and in order to

For treatment of damaged piles, concrete layers with reinforcing bars covered by steel casing at the location of damaged joints are used, which performs two functions:

In longitudinal direction, (2m) length (20 $\phi$ 25 mm) and ( $\phi$ 16mm @150mm) stirrups covered by (3mm) steel plate casing with length of (2m) are used. Concrete with compressive strength of (33MPa) is poured inside the mold (steel casing) after removing of weak layers and install of longitudinal and transverse reinforcement as shown in Figures (4) and (5).

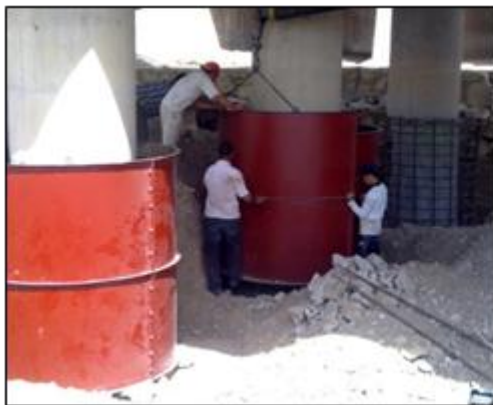
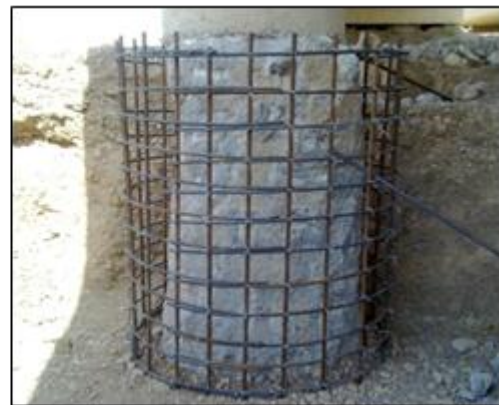
Figure 4: Installation of Steel Mesh and Steel Casing (Before Concrete Poured)

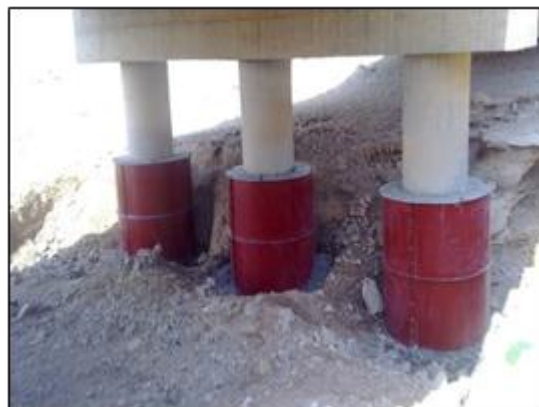
Figure 5: Treatment of damaged joint by RC Confined by Steel Casing (After Concrete Poured)

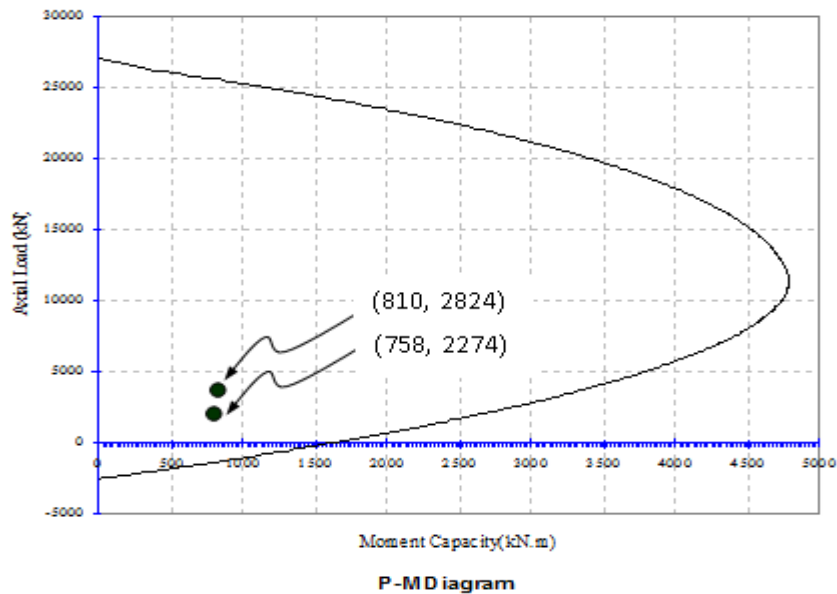
By using DT Column software (10) (circular column analysis), the interaction diagram (P-M diagram) is drawn and presented in Figure (6). The diagram refers to that the cross-section of pile and reinforcement is safe and adequate to resist the applied axial and bending moments.

**Figure 6:** Interaction diagram (P-M diagram)

Check the capacity of pile by using interaction diagram (See Figure (6))
